Numerical Simulation of the Daikai Station Subway Structure Collapse due to Sudden Uplift during Earthquake

Norimitsu Kishi, Ph.D., M.ASCE¹; Keiichiro Sonoda, Ph.D.²; Masato Komuro, Ph.D.³; and Tomoki Kawai⁴

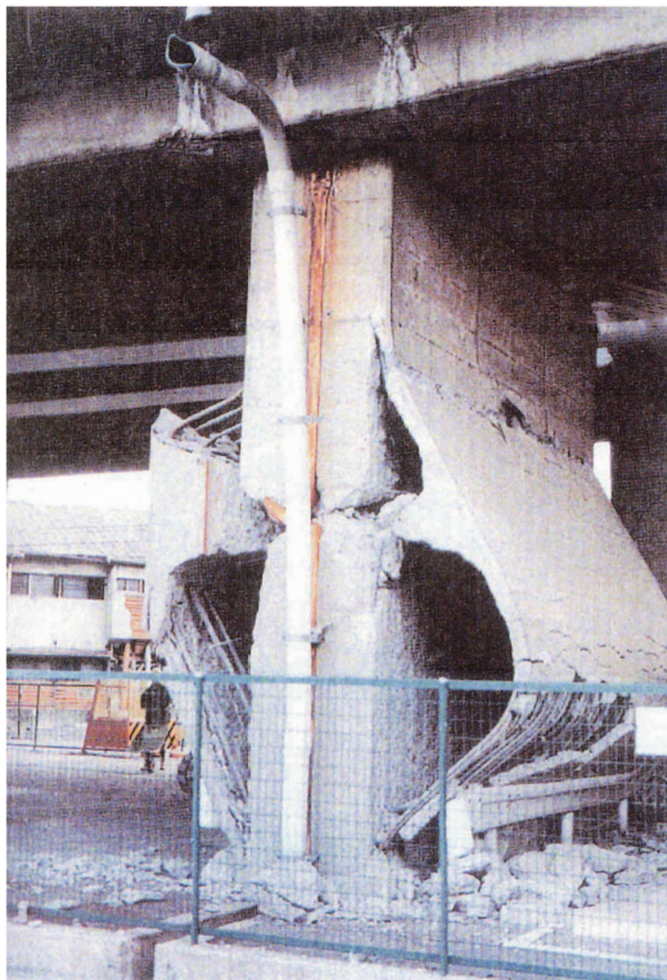
Fig. 1. (Color) Example of the compression failure of an RC bridge pier. (Image by Keiichiro Sonoda.)

However, the compression failure of RC bridge piers, as shown in Fig. 1, and the collapse of the Daikai Station subway structure (Hanshin Expressway Public Corporation 1995) could have been caused by the observed vertical motion. In particular, the significant damage to the Daikai Station subway structure shown in Fig. 2 was the first severe failure case worldwide used to modify the general practice of structural and geotechnical engineers regarding underground structures with better seismic performance than surface structures because underground structures that do not cross an active fault are influenced by the deformation of the surrounding ground if there is no liquefaction during an earthquake and if they have a smaller unit weight than that of the subsoil. Because the structure was significantly deformed and approximately symmetrically with respect to the shortened central columns due to axial compression failure, it is not easy to explain how the damage was induced by the strong lateral vibration of the earthquake.

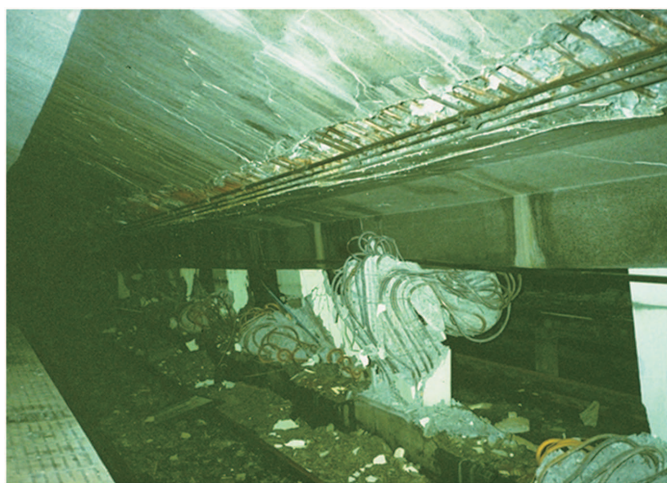
Fig. 2. (Color) Compression failure of the central columns of the Daikai Station subway structure. (Reprinted with permission from Sakurai 2014.)

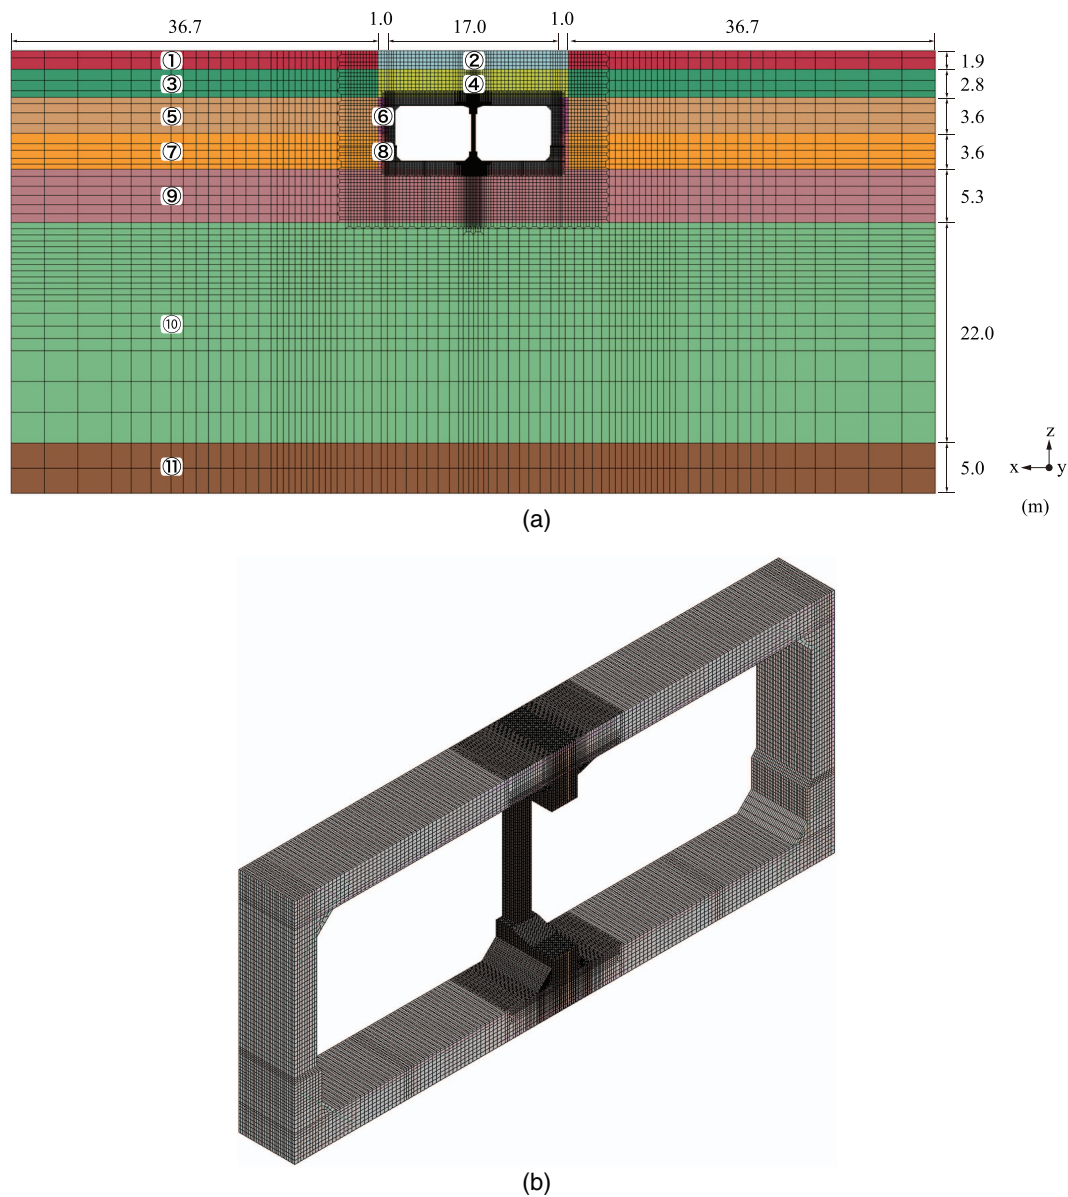
Fig. 4. (Color) Finite-element model of the Daikai Station subway structure: (a) discretization of the cross section including the surrounding soils; and (b) 3D discretization of the main section of the station.

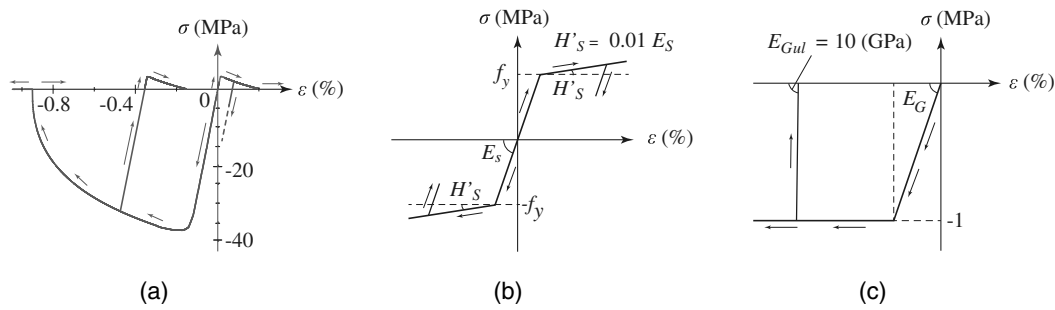
Fig. 5. Constitutive models for materials: (a) concrete; (b) rebar; and (c) overburden soil and backfilled soil.

A variety of constitutive models for concrete are provided in LS-DYNA (Livermore Software Technology Corporation 2016). In this study, the Karagozian and Case concrete model (KCC model or MAT072R3 in LS-DYNA), as shown in Fig. 5(a), was employed (Malvar et al. 1997) to better regenerate the axial compression failure of concrete. This model can effectively capture key concrete behaviors, including postpeak softening and confinement effects (Wu et al. 2012). Additionally, the model can automatically

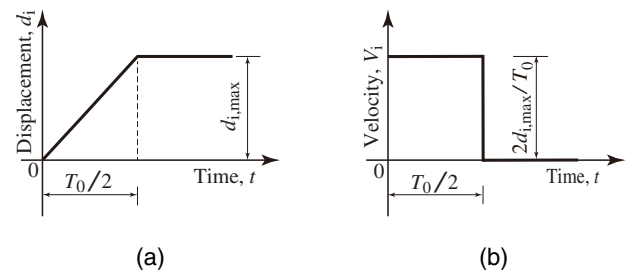
Fig. 6. Schematic time histories of the input wave: (a) displacement d_i ; and (b) velocity V_i .

In this study, a numerical simulation was performed by increasing the velocity of the input displacement (referred to hereinafter as the input velocity) from $V_i = 0.5$ to 4 m/s for two durations of loading: $T_0/2 = 5$ and 50 ms, as mentioned previously, with the former associated with high-frequency ground motion (100 Hz) excited prior to a lateral earthquake input and the latter associated with comparatively low-frequency motion (10 Hz). The maximum displacement $d_{i,max}$ for each velocity V_i is listed in Table 2.

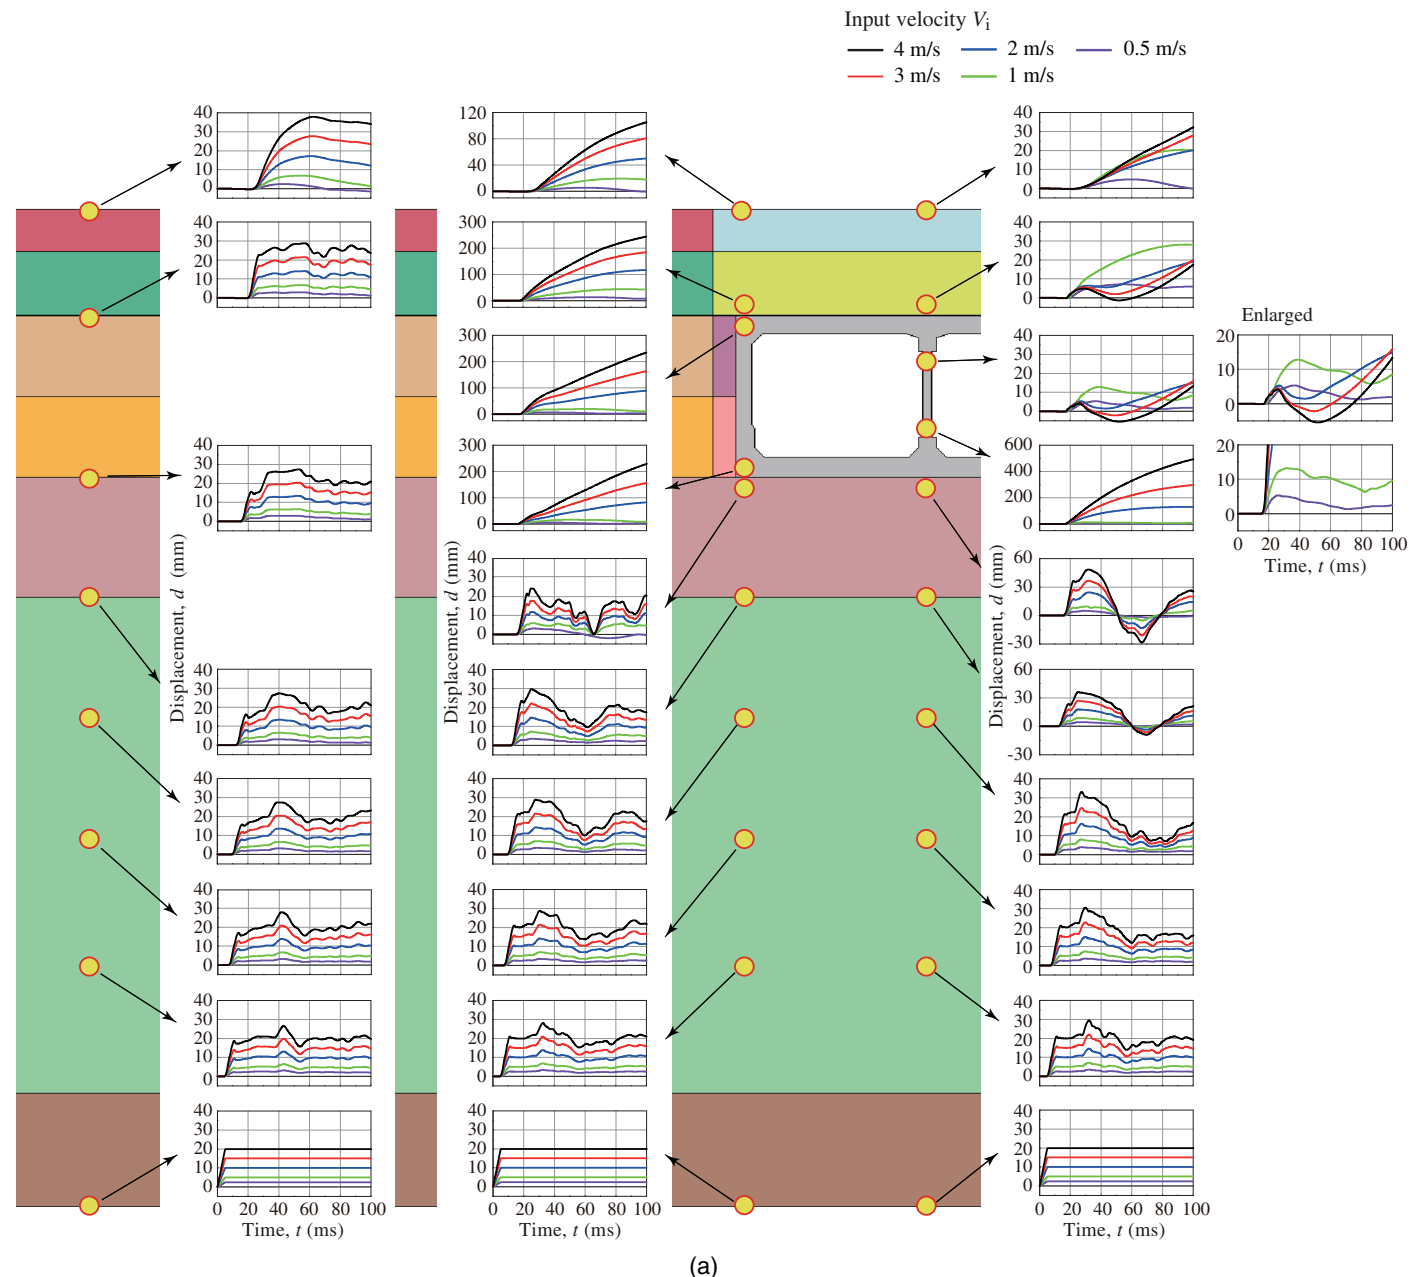
Fig. 7. (Color) Time histories of displacement d : (a) loading duration $T_0/2 = 5$ ms; and (b) $T_0/2 = 50$ ms.

Figs. 7(a and b) and 8(a and b) are the results for the loading durations of $T_0/2 = 5$ ms and $T_0/2 = 50$ ms, respectively. In these figures, to investigate the propagation characteristics of a wave passing through the station structure from the base stratum, each time history is indicated for points along the axes of the central column and sidewall. Reference time histories for a wave that is not influenced by the substructure are also indicated along the vertical line 10 m inside the free ends of the soil layers.

From the distribution of the reference time histories of the displacement for the soil layers shown in Fig. 7(a), it can be observed that the amplitude of the wave crest gradually decreases up to a similar depth level as that of the lower surface of the base slab and increases near the subsurface layer. The amplitude at the ground surface is almost twice that of the input displacement. This result may be due to the effect of the reflection wave when the axial stress is released at the ground surface.

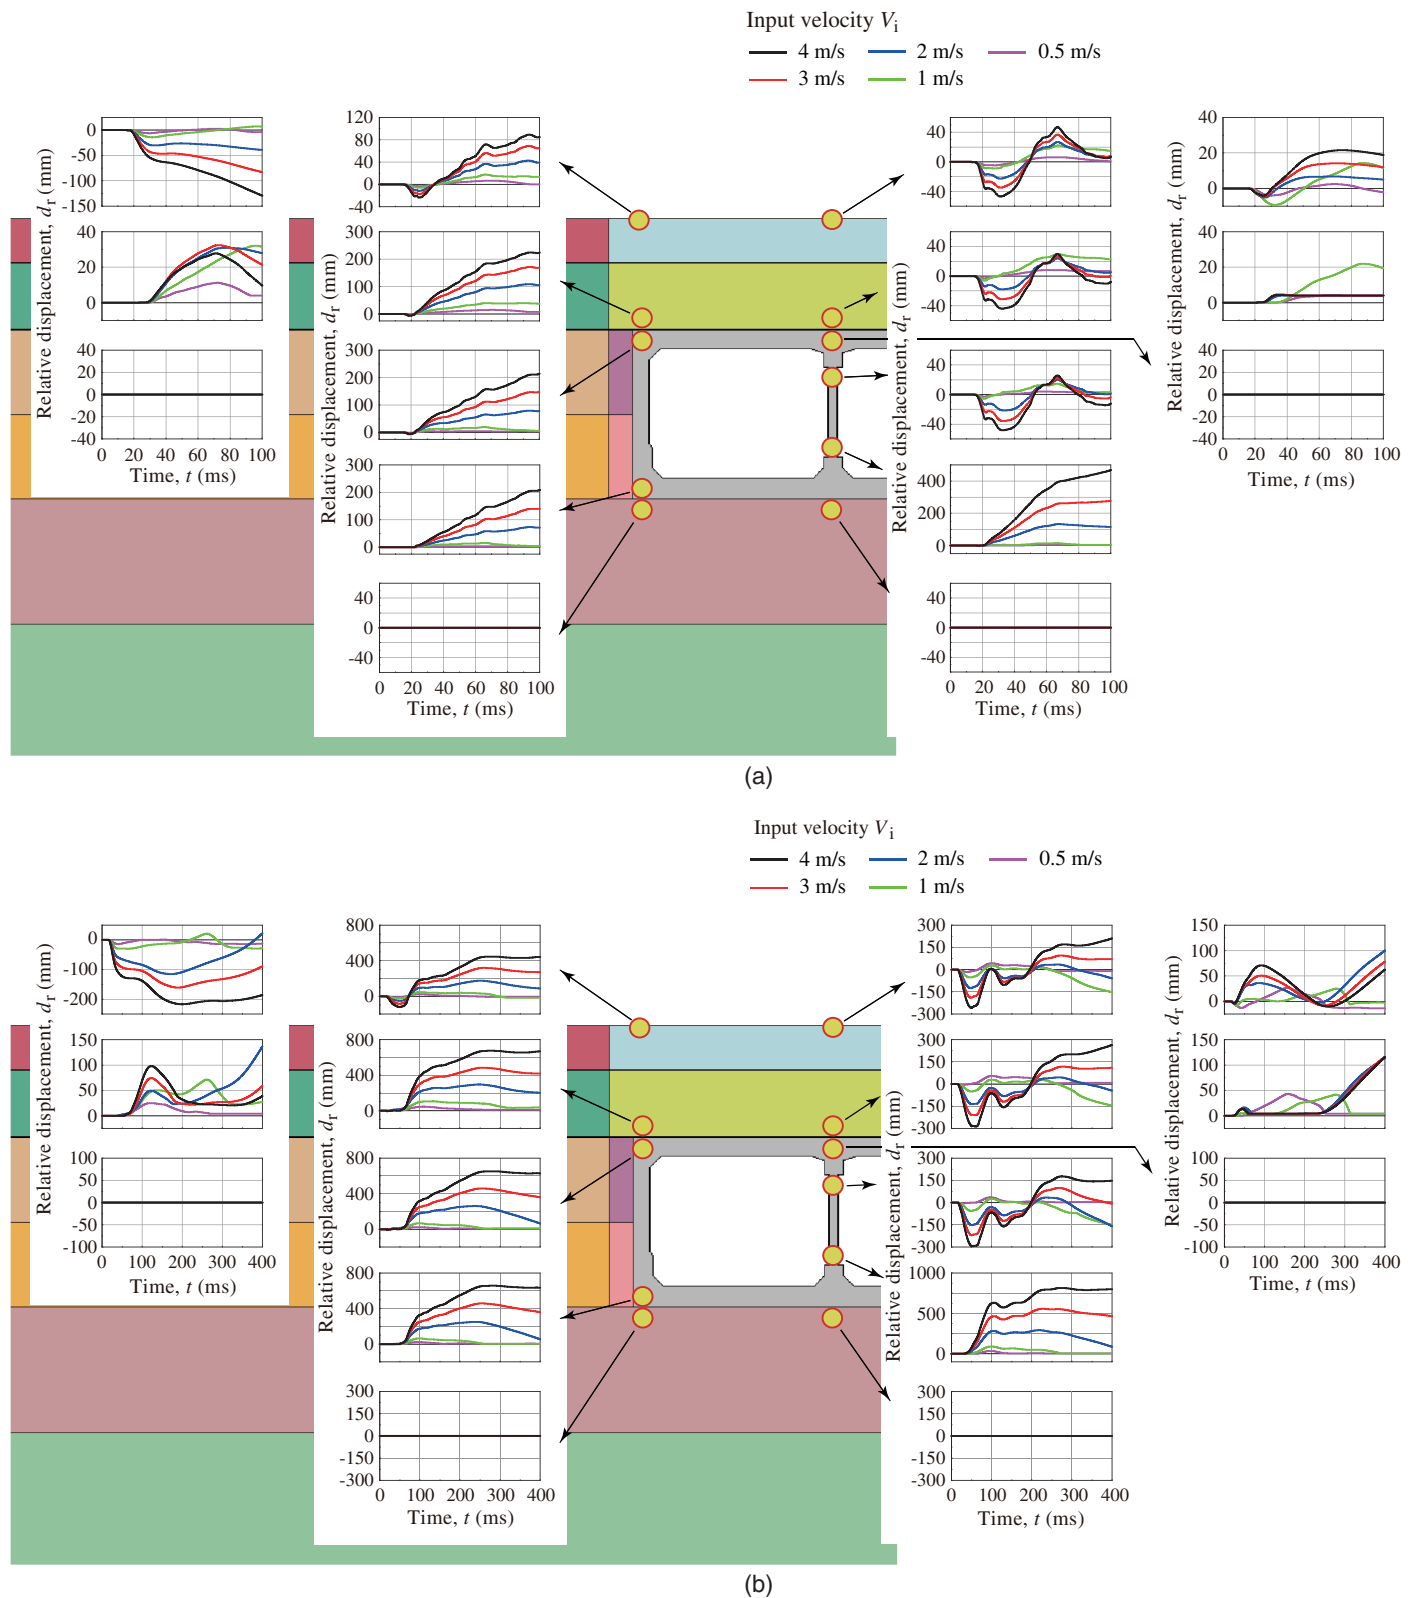
Fig. 8. (Color) Time histories of the relative displacement d_r , which refers to the displacements at the upper point of the soil layer just below the base slab and at the ceiling slab: (a) loading duration $T_0/2 = 5$ ms; and (b) $T_0/2 = 50$ ms.

From Fig. 8(a), because the relative displacement d_r at the ground surface on the axis of the sidewall, which refers to that of the ceiling slab, is distributed in the negative region and reaches

From Fig. 8(b), it is observed that the relative displacements d_r at the ground surface on the two axes, which refers to each distribution at the ceiling slab, are approximately 50 mm larger than those in the case of a loading duration of $T_0/2 = 5$ ms [Fig. 8(a)]. However, the distribution characteristics are almost similar to time $t = 100$ ms. When the input velocity is equal to or greater than $V_i = 2$ m/s, because the relative displacement d_r at the bottom of the overburdened soils on the axis of the central column, which refer to that of the ceiling slab, abruptly increases at time approximately $t = 250$ ms, the overburden soils separate from the ceiling slab and begin to substantially rise.

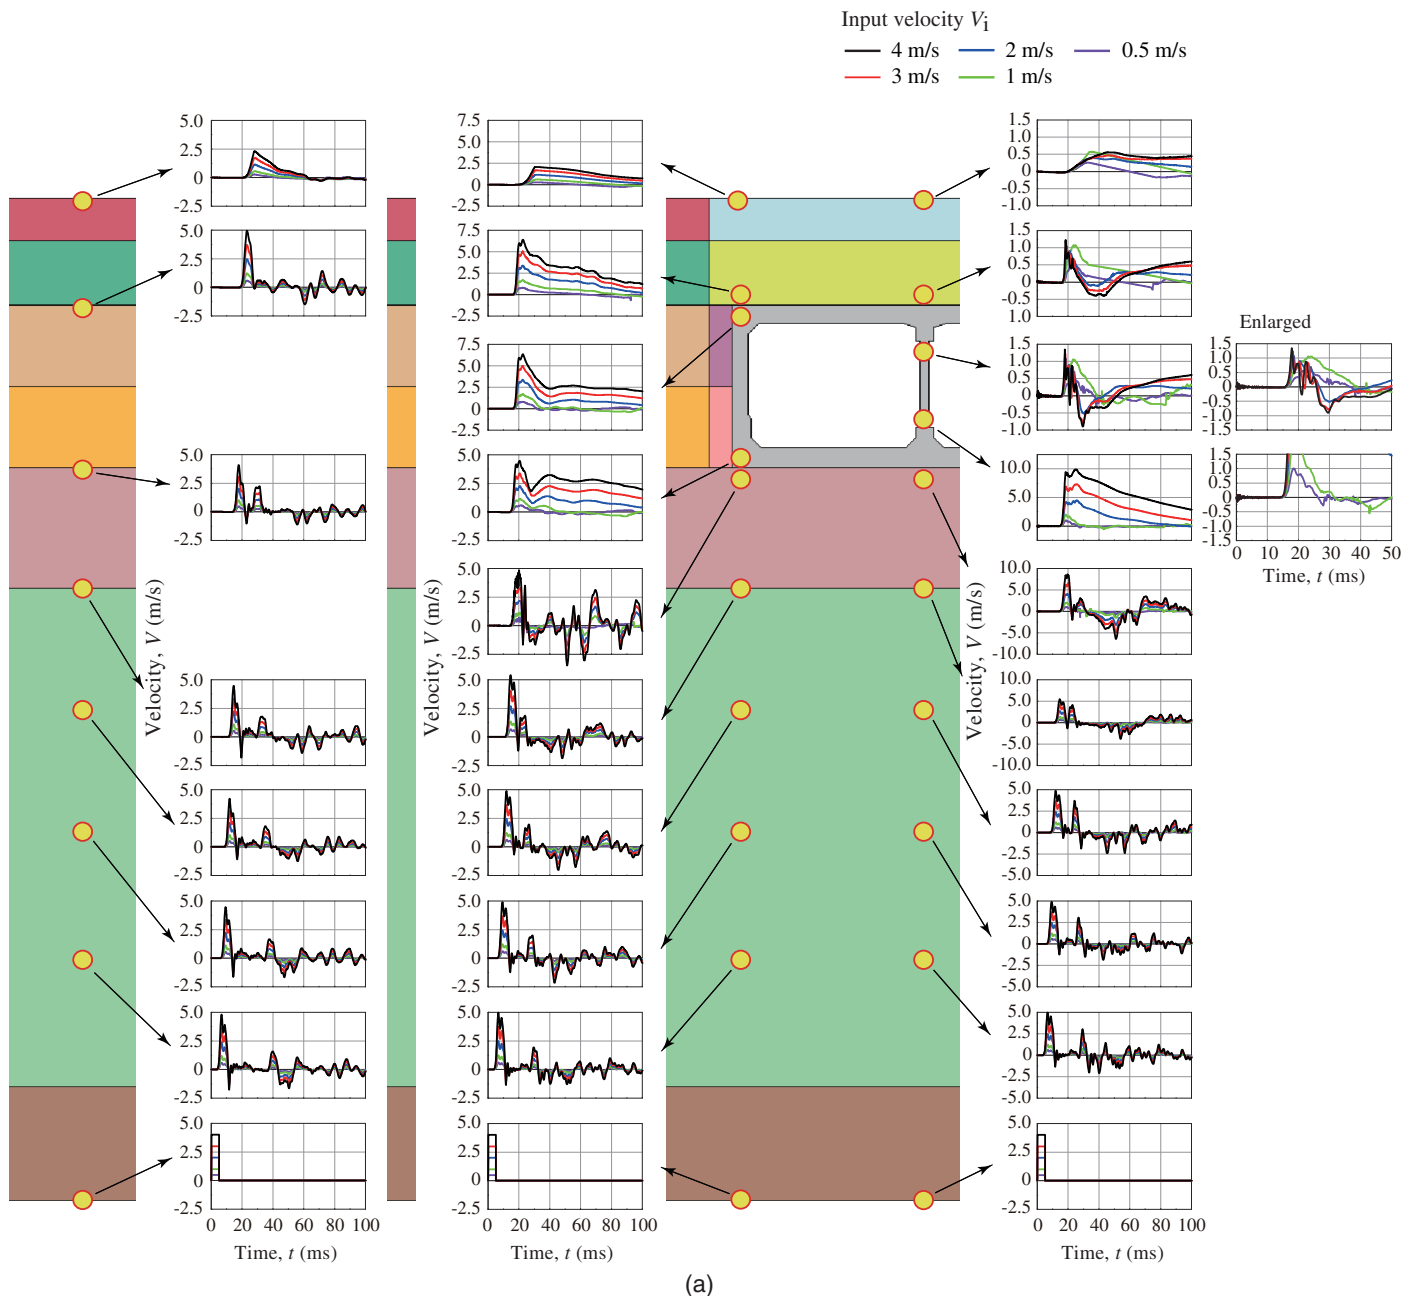
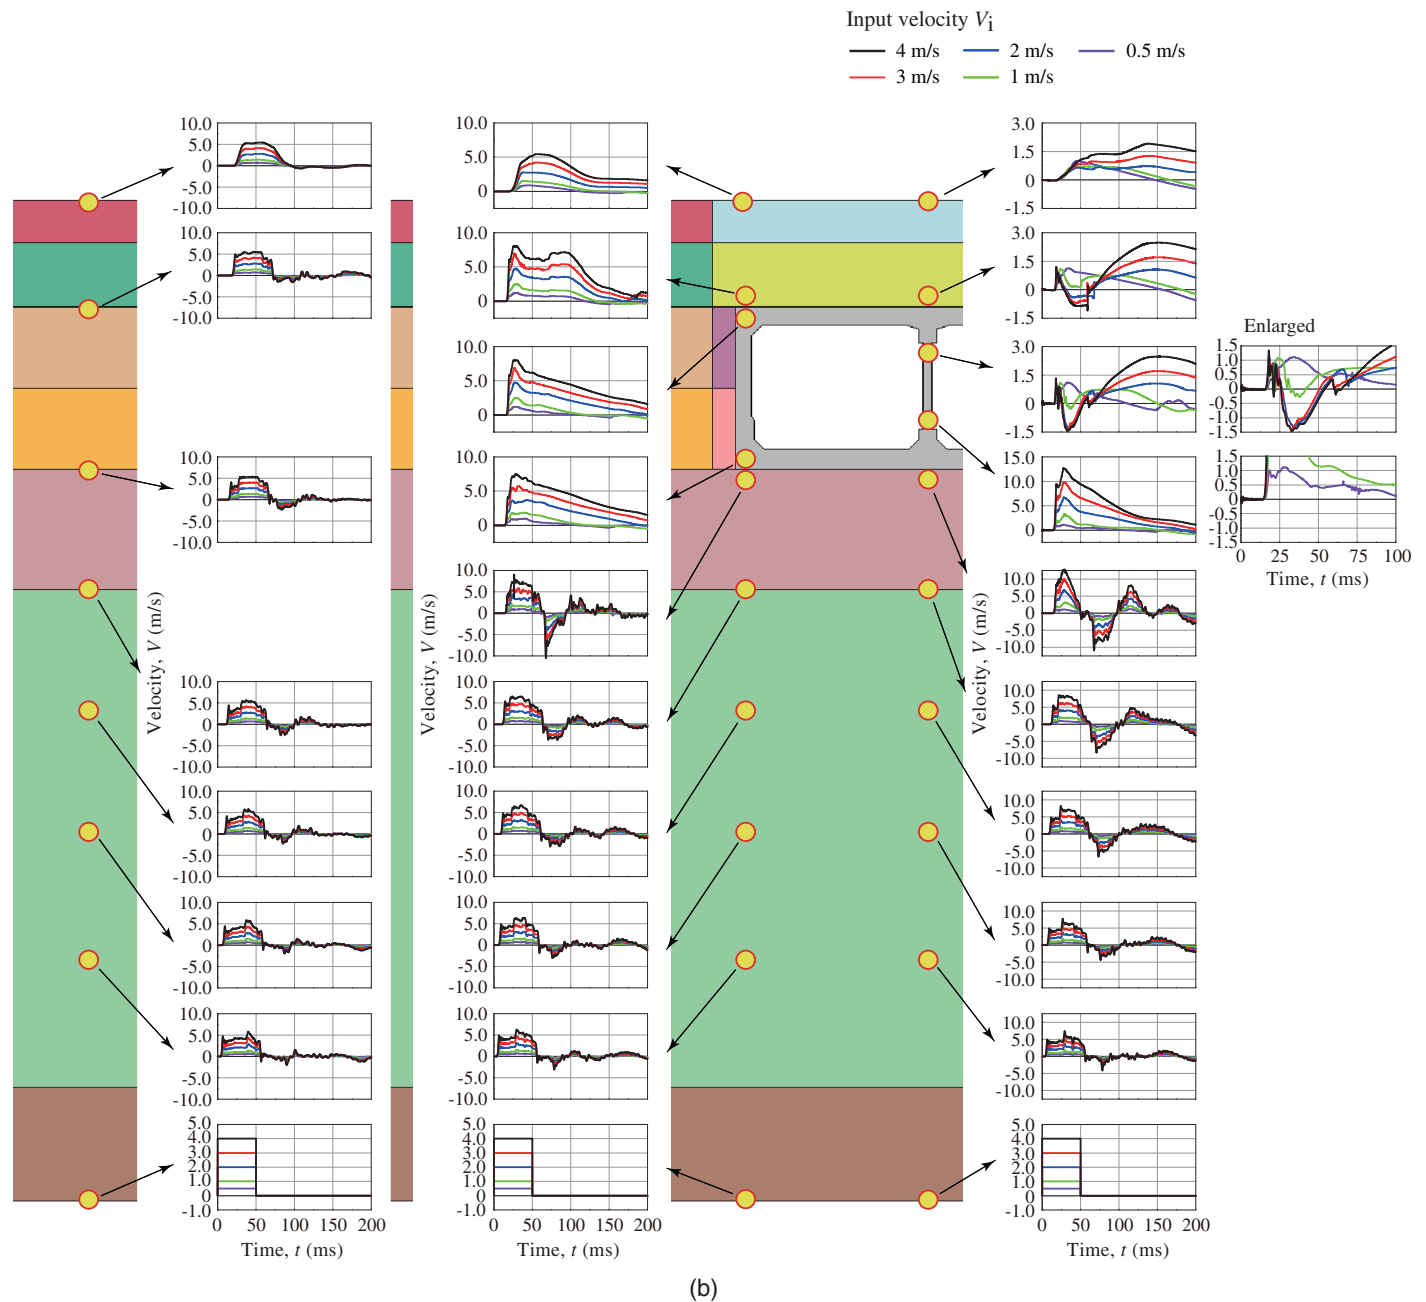
Fig. 9. (Color) Time histories of the particle velocity V : (a) loading duration $T_0/2 = 5$ ms; and (b) $T_0/2 = 50$ ms.

Based on a comparison of the time histories of the particle velocity V at the two points on the column, when the input velocity is equal to or greater than $V_i = 2$ m/s, the amplitude of the wave at the lower point maintains an approximately similar value after separation from the soil layer and then gradually decreases. Additionally, at the upper point, the amplitude remains less than $V = 1.5$ m/s and decreases to a negative value. This result suggests that due to the comparatively low axial stiffness of the column, the column may reach axial compression failure, and the stress wave at the beginning of loading may not directly propagate toward the upper part of the column. The axial stress in the column due to particle movement was estimated. The maximum particle velocities V_{\max} in the case of the input velocities $V_i = 2, 3,$ and 4 m/s are approximately $V_{\max} = 4.5, 7,$ and 10 m/s, respectively, and the stress that corresponds to each maximum velocity V_{\max} is evaluated, assuming that the concrete column is an elastic body, using Eq. (3) with $\sigma = 36, 56,$ and 60 MPa. From these results, as discussed in the previous section, it is confirmed that the column may collapse with axial compression failure because the compressive strength of the concrete was $f'_c = 37$ MPa.

When the input velocity is $V_i = 1$ m/s, the particle velocity V at the upper point of the column is approximately $V = 1$ m/s at approximately $t = 25$ ms and then decreases approximately linearly to zero at time $t = 40$ ms. Moreover, at the lower point, even though the velocity V at time $t = 20$ ms is greater than $V = 1.5$ m/s, the velocity decreases to zero around $t = 30$ ms. This change suggests that after time $t = 25$ ms, the reflection wave from the upper point may not directly propagate to the lower point, potentially because horizontal circumferential cracks may occur along the column, and the stress wave may disappear, as supported by the axial stress trend at a particle velocity of $V = 0.5$ m/s and tensile stress of $\sigma = 4$ MPa at time $t = 30$ ms.

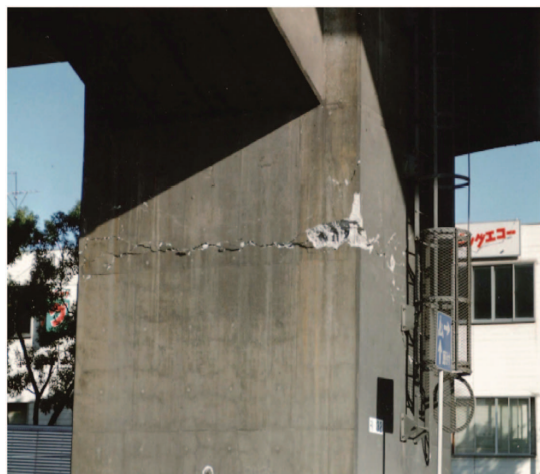
Fig. 11. (Color) Example of horizontal circumferential cracks that occurred in an RC bridge pier. (Image by Keiichiro Sonoda.)

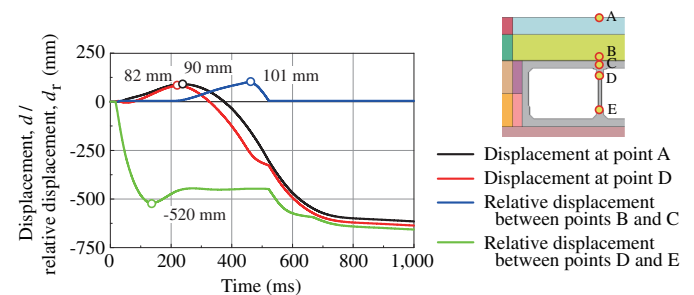
Fig. 12. (Color) Comparisons of the time histories of displacement and relative displacement on the axis of the central column for an input velocity $V_i = 4$ m/s and loading duration $T_0/2 = 5$ ms.

soils. Additionally, the overburden soils separate from the ceiling slab with a maximum distance of approximately 100 mm and contact the slab again due to the effect of gravity after a time of approximately $t = 500$ ms. Because the relative displacement between the upper point and lower point of the column increases monotonically to more than 500 mm due to uplift loading, the axial compression failure of the column proceeds continuously. Even the relative displacement maintains a constant value when the overburden soils separate from the ceiling slab. After the soils contact the slab again due to gravity, the displacement gradually increases, and the compression failure of the column proceeds.
