STRENGTHENING EFFECT OF POPYPROPYLENE BANDS ON BENDING, SHEAR, AND TORSIONAL BEHAVIORS

by
TA QUY HUNG

A Dissertation Submitted in Partial Fulfillment
of the Requirements for the Degree of
Doctor of Philosophy

Division of Engineering
MURORAN INSTITUTE OF TECHNOLOGY

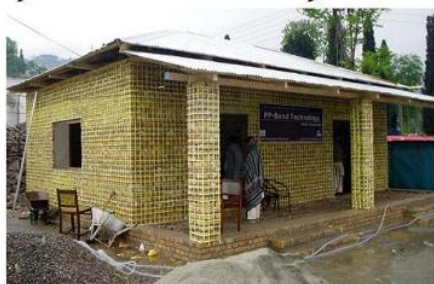
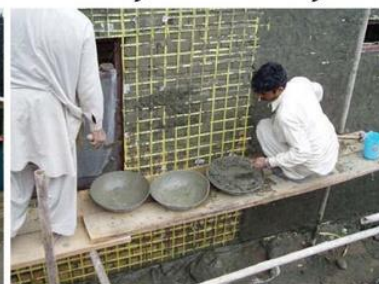
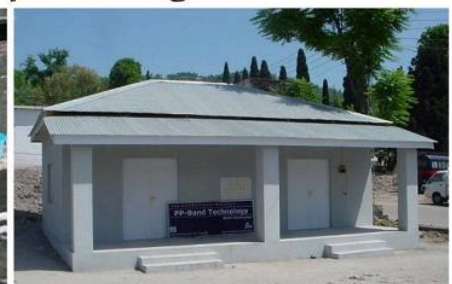
Figure 2.2. PP band mesh retrofitting procedure for masonry house

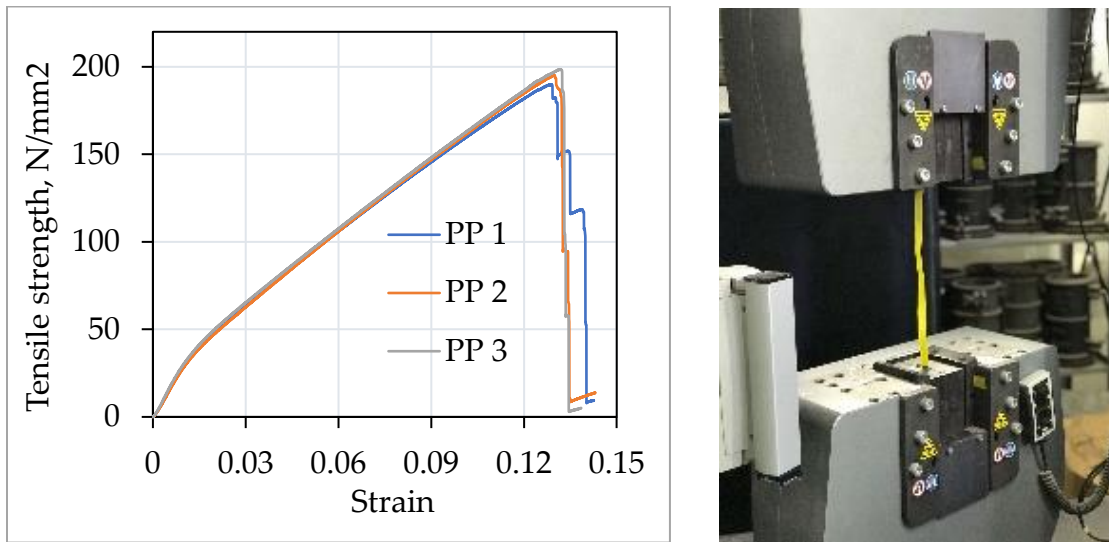
Figure 2.4. Direct tensile strengths of PP bands

The specimens were strengthened using a PP band (popularly used as a carton packaging material). We evaluate the tensile properties of PP band with dimensions $15.5 \times 0.5 \times 500$ mm (width \times thickness \times length) according to JIS Z1527:2002. Figure 4.4 exhibits the setup used for the tensile test. The properties of the PP band used in this investigation are listed in Table 2.1.

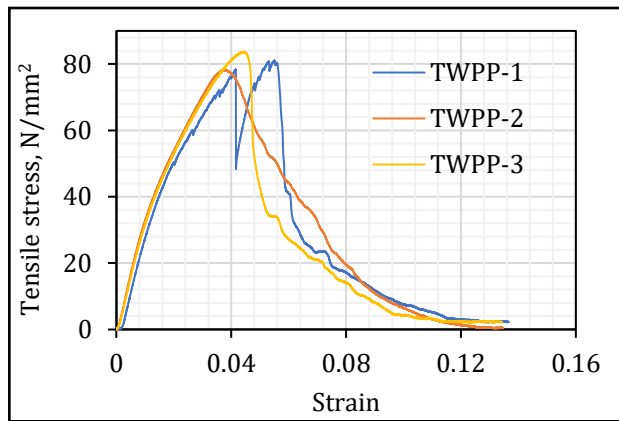
Figure 2.6. Tensile stress-strain curves and failure patterns in the investigated cases

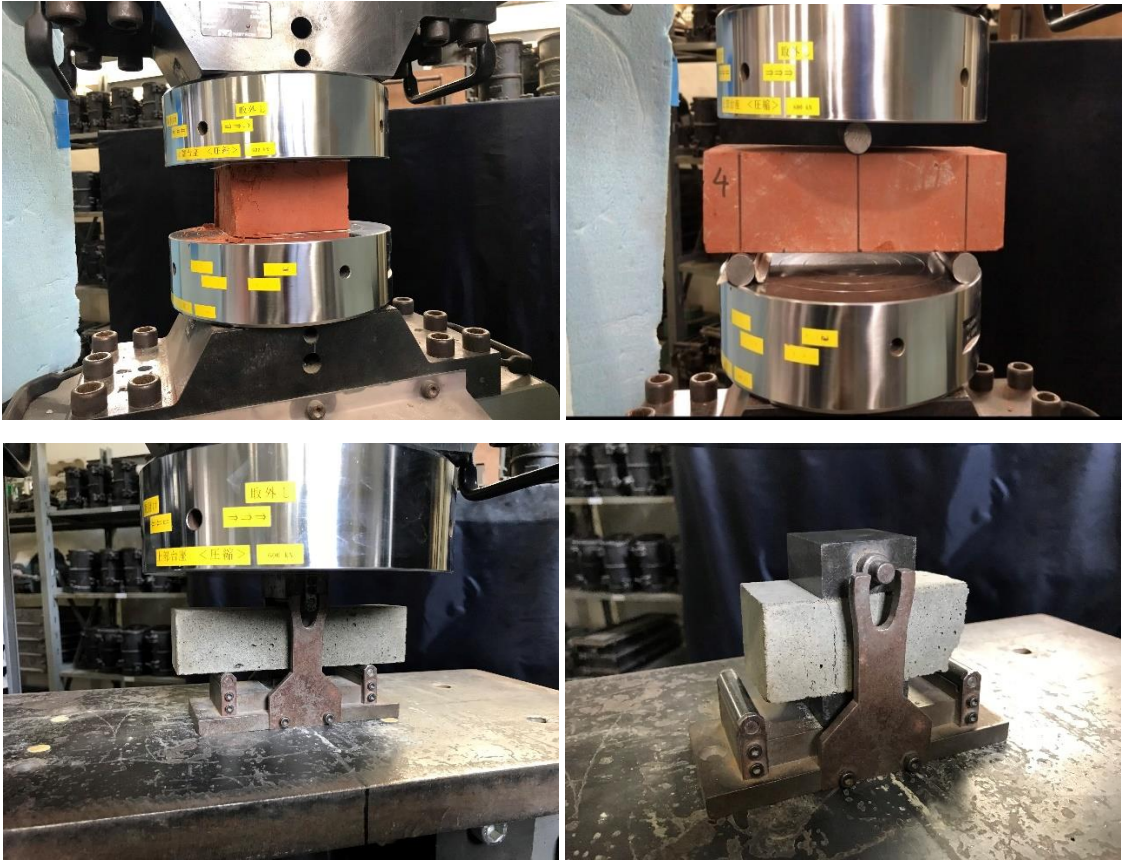
Figure 3.6. Compressive and flexural test for brick and mortar

kept in the steel mold for 24h after casting, and the samples were removed from the molds after they were kept in the curing water until the date of testing. The flexural strength was measured by means of three-point bending tests, whereas the compressive strength was determined on the halves of the specimens after the bending tests. The mechanical properties of the mortar are listed in Table 3.1 together with the coefficient of variation (COV) in parentheses.

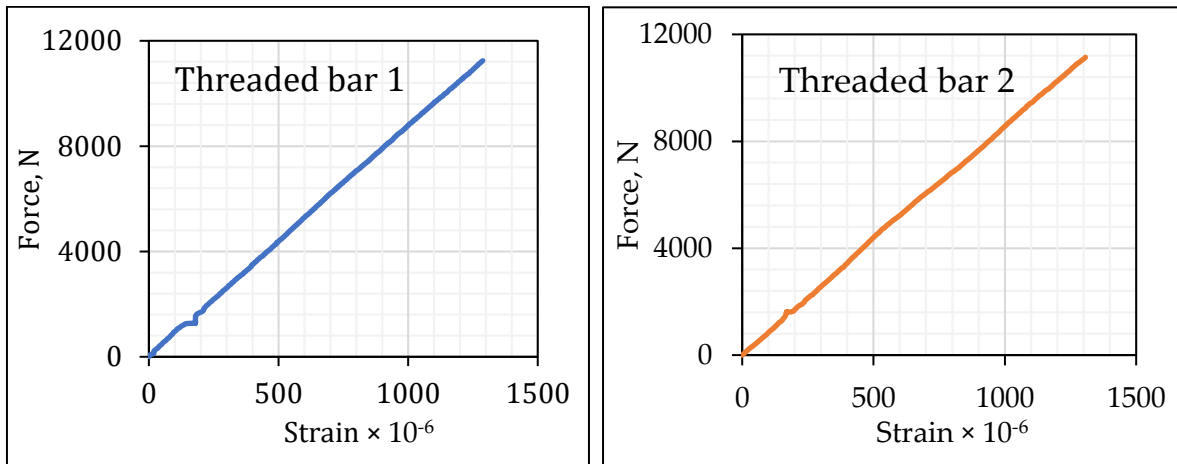
Figure 3.11. Directional tension of the threaded bar

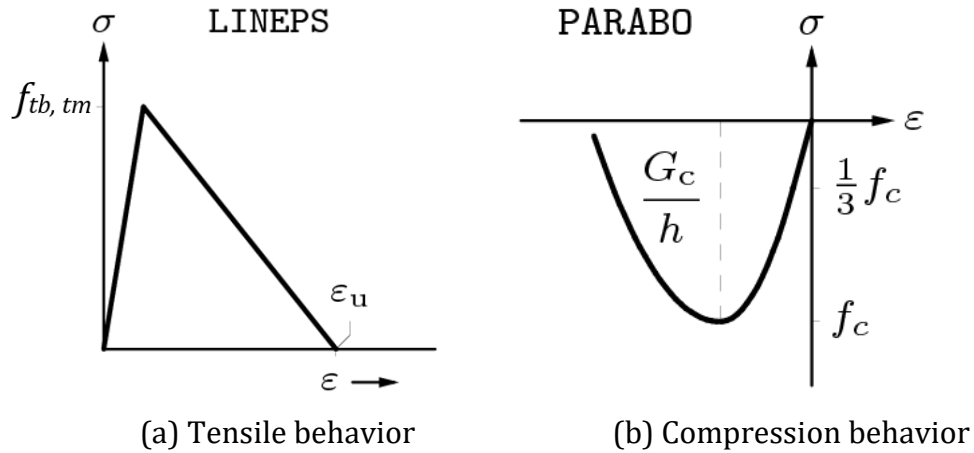
Figure 4.7. Constitutive models for brick and mortar

The two components (bricks and mortar layers) are described as a continuum, and discretised using 3D eight-node element of reduced integration with orthogonal hourglass control (HX2L). The behavior of the brick unit and mortar is described using a Total-strain based crack model in all three experiments, available in DIANA software. DIANA's total strain based constitutive model defines the tensile and compressive behavior of a material by a stress-strain relationship. The tensile and compression behavior of the units and the mortar was assumed to be linear-ultimate crack strain, parabolic model, respectively, see Figure 4.7.
