# Analysis on Causes of Large-scale Ordovician Karst Water Inrush at 27080 Working Face of Eastern Caoyao Mine

Song-ying LI\*, Bo FAN\*\* and Ping-ping LUO\*

The large-scale Ordovician Karst water inrush occurred at 27080 working face in Caoyao Eastern Mine on December 23th, 2006, the maximum water inflow arrived at 1693 cubic meters per hour. The source of this water inrush was the Ordovician karst water; the dynamic condition was high hydraulic pressure; the water conducted channels were formed by hydraulic pressure and rock pressure in the weak area of floor; and the space of that was offered by excavation. The proposals for preventing and controlling water were put forward.

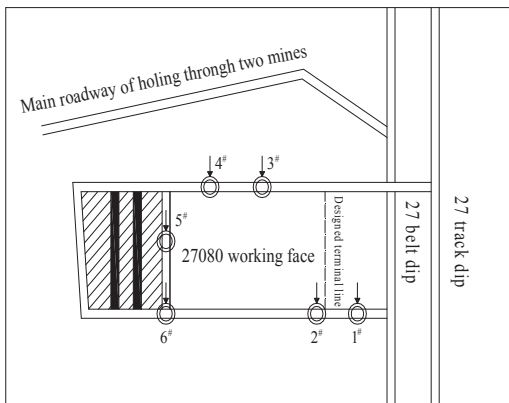
Fig.1 27080 working face plane position sketch map

The 27080 working face is situated in the western flank of the 27 district dip of eastern Caoyao mine. The lengths of the strike and dip are 125 meters and 88 meters, respectively, and the thickness of coal seam, being inner thick but outer thin, is from 1.8 to 5.9 meters, the average thickness 3.7 meters and the reserves 56.9 thousand tons. The top and bottom of it are respectively the 27060 and 27100 working face, neither of which is mined (Fig. 1). The elevation of working face is from 275 to 310 meters, respectively corresponding to the ground elevation from 680 to 702 meters, and the mining depth is from 380 to 405 meters. The original water level of the Ordovician aquifer is 538 meters, while the geological condition of this working face is relatively simple and the geological structure such as fault has not been examined. The dip angle of coal seam is from 8 to 18 degrees, averagely 13 degrees. The 27080 working

face commenced coal winning on November 13th, 2006, the length of which was 45 meters and the workable reserves 25 thousand tons. In the process of coal winning, the open-off cut needed to be made due to the water inrush and caving of roof for two times. While the length of the first district sublevel was 15 meters and that of the second and third one were not more than 7 meters and 10 meters, respectively. Furthermore, these two coal pillars did not both arrive at 5 meters.

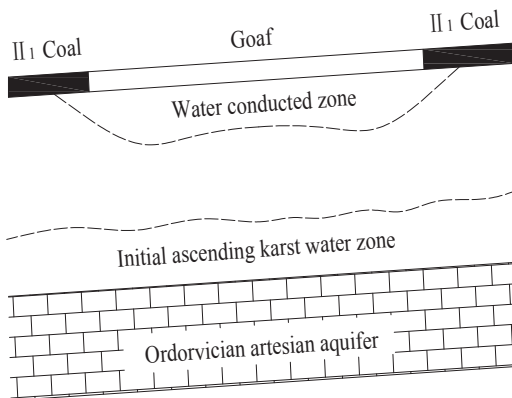
**Fig. 2 Analysis map of Ordovician karst water inrush after mining**

To consult other experiential data of mines,  $C_p$  and  $H_d$  are, respectively, adopted as 15 meters and 12 meters. The average hydraulic pressure of floor at the 27080 working face is 2.5 MPa and the distance from coal layer to the Ordovician top is merely 43.5 meters, and follows that substituting these data into Eq.(1), it yields  $T_s = 0.1515$  MPa per meters. Referring to the nationwide practical information and Mine Hydrogeological Regulations, it suggests that the coefficient of water inrush at the breaking floor is generally not more than 0.06 MPa per meters and that of normal zone not more than 0.15 MPa per meters as well<sup>(3)</sup>. In contrast with above data, it is, however, not difficult to find that  $T_s$  of 0.1515 is more than 0.15 and far more than 0.06. By this token, even though the floor is integrated at the 27080 working face, there exists a risk of water inrush (Fig. 2). Furthermore, the

breakage of floor and the suspending roof or the less-caving destructively extending to the floor are all

to raise the risk of water inrush.

Consequently, this water inrush was a result associated with hydraulic and rock pressure which jointly performed on the weak district sublevel of floor, and the destructive depth of floor was also increased by mining by areas. In conclusion, the source of water inrush was provided by the artesian aquifer of the Ordovician karst water, the dynamic condition was the high hydraulic pressure and the space of that was offered by the mining activity, moreover, the water conducted channels were formed by the combined effect of hydraulic and rock pressure on the weak district sublevel of floor. By means of the calculational analysis on the coefficient of water inrush, the risk of water inrush at the 27080 working face was validated as well.

By virtue of the comprehensive analysis on the information of the geophysical prospecting and boring, the grouting reinforcement should be performed in the district sublevel accessible to the water inrush and the fault structure may be sewn up<sup>(4)</sup>. Moreover, the weak district sublevel could be reconstructed for the improvement upon resisting hydraulic pressure of the impermeable layer. After above process, it follows that the necessary countercheck of the geophysical prospecting and boring could be also made in order for the validation of the grouting effect, as well as eliminating the threaten of the karst water inrush.
